KUE KEN 120S

Complete refurbishment of primary jaw crusher.

International Crusher Solutions

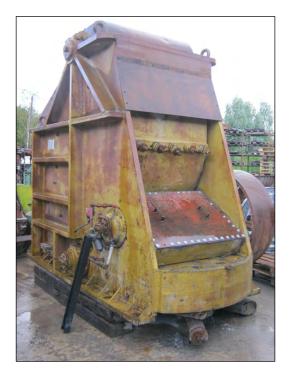
Damaged draw back bolts that we replaced. Sump plate bolts missing, we re-drilled and taped damaged holes and fitted new bolts c/w a new cover plate.

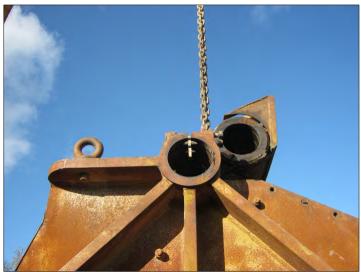
Work Starts Striping out hinge pin and eccentric shaft

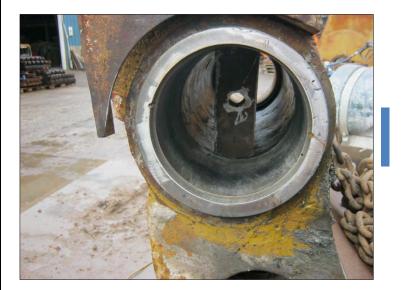
Jaw stock hinge Pin bush totally worn away.

New hinge pin bushes to be fitted to both sides of jaw stock.

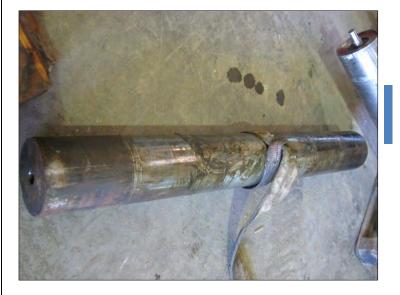
Hinge pin removed and inspected.

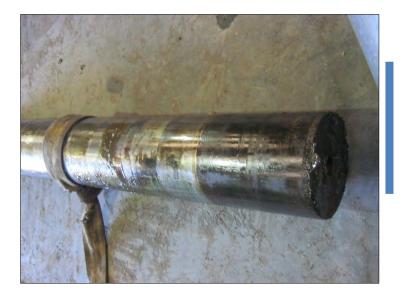
Damaged shaft to be replaced

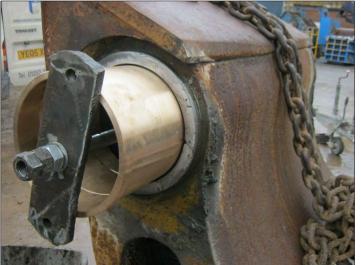
New jaw stock hinge pin bush being fitted.

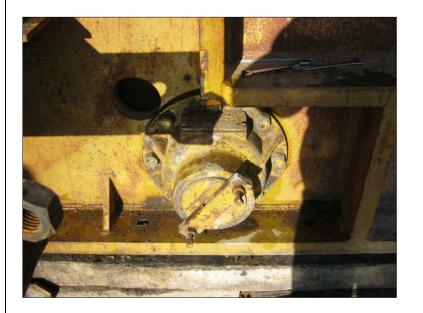
Swing jaw guide striped down for inspection.

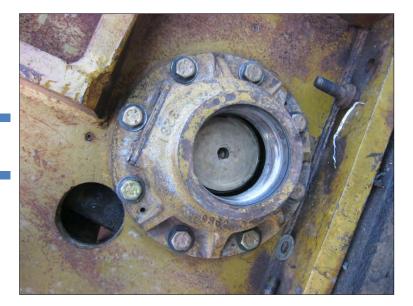
No oil found.

New seal fitted to swing jaw guide.

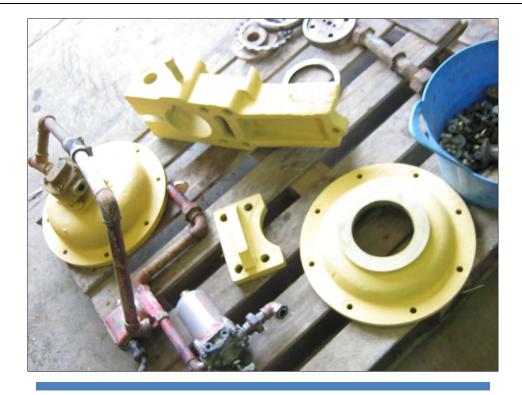
Pump striped and cleaned with new gasket set.

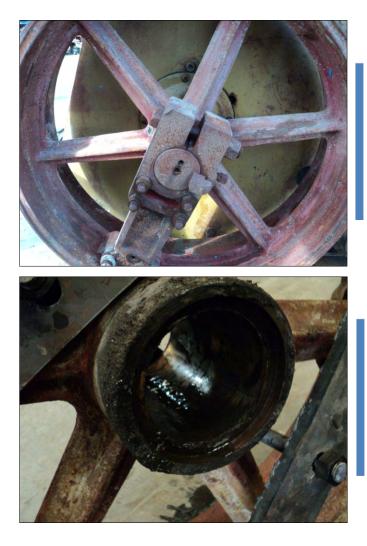
Flywheel to be removed due oscillation movement.

After removing fly wheel bronze bush was found to be worn out.

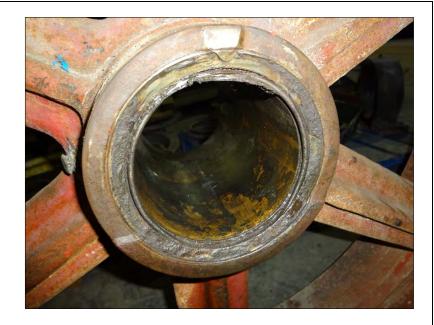
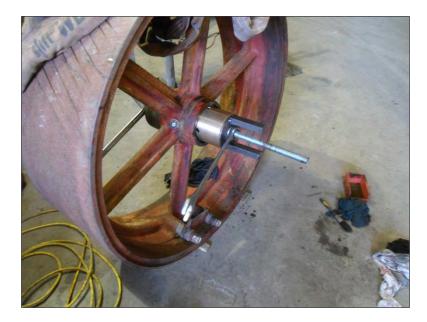
Damaged and worn flywheel bush

Pressing out worn bush

Fitting new bush to pulley.

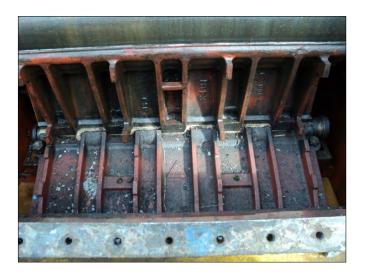
Toggle and pitman before removal and inspection.

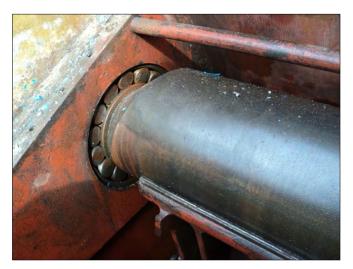
Bearings rusted and in poor condition due to lack of lubrication.

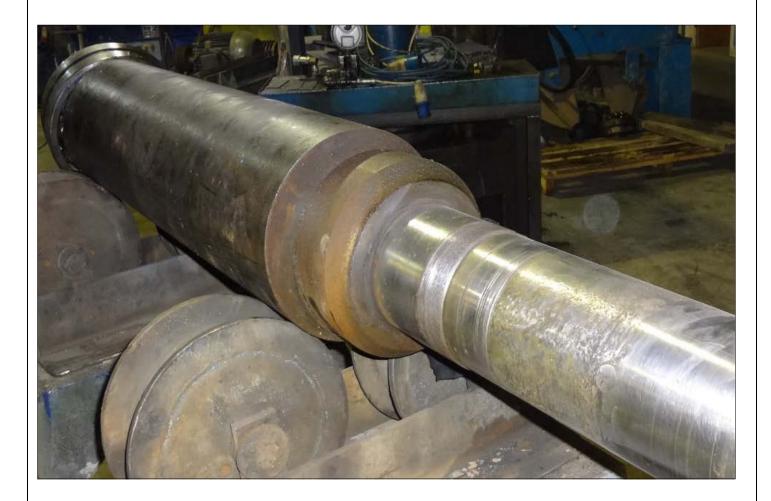
Damaged pitman shaft

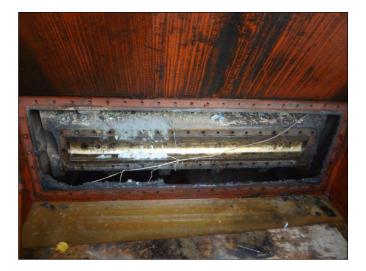
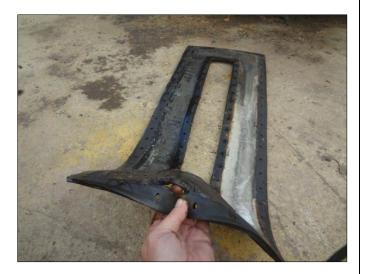
Damaged diaphragm

Removal of diaphragm and diaphragm frame.

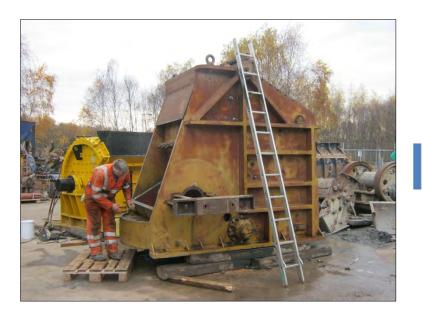
Tapping holes out for toggle cover.

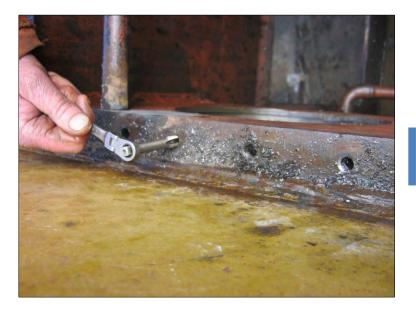
Re-tapping toggle cover plate holes to ensure the cover plate is sealed

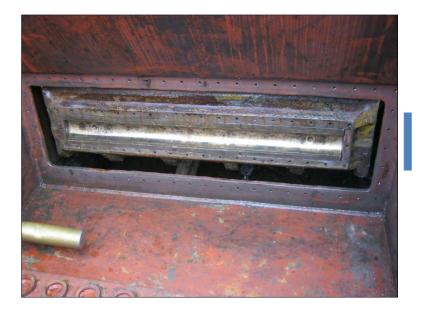
Damaged diaphragm removed and diaphragm frame holes re-tapped.

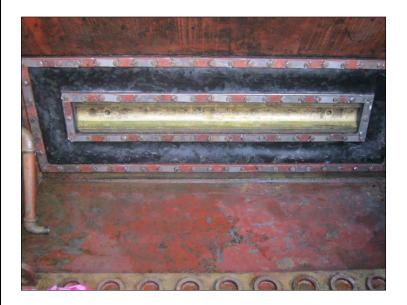
New diaphragm fitted.

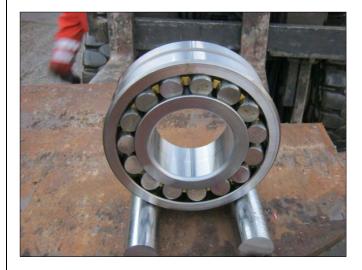
New eccentric shaft bearing.

Pressing bearings into main frame.

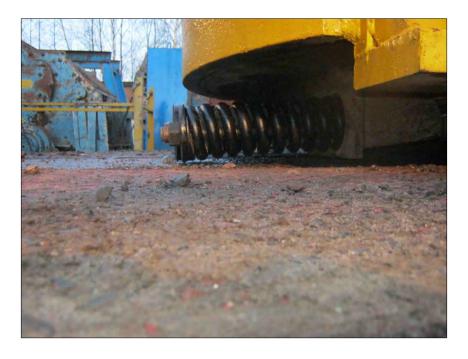
New draw back rods and springs fitted
